## U. S. NAVY T-45A DEPARTURE AND SPIN EVALUATION

Major Joseph A. Mortensen, USMC

T-45 Project Coordination Office  
Naval Air Warfare Center, Aircraft Division  
Patuxent River, Maryland U.S.A.

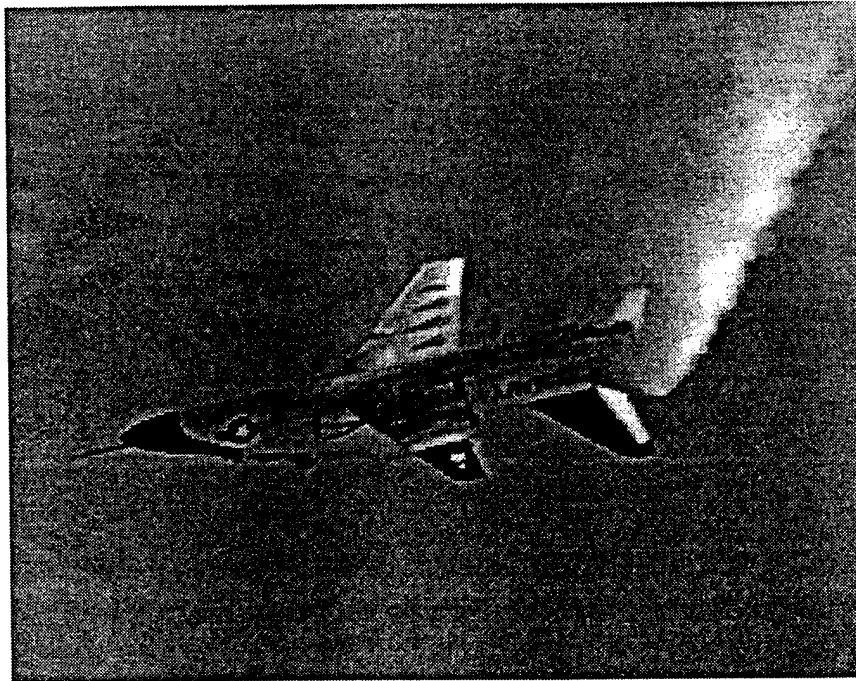
The T-45A Goshawk (see Figure 1), manufactured by MDA (primary contractor) and British Aerospace (BAe), is a jet trainer currently being phased in as the U.S. Navy's replacement for the aging T-2C and TA-4J aircraft. Its design is based on the British Aerospace HAWK. The T-45A is a low wing, tandem seat, single engine aircraft designed for shore-based and carrier-based operations. The test article BuNo 163599 (T003) was powered by an instrumented production Rolls Royce F405-RR-401 turbofan engine which was capable of producing 5,527 lb<sub>f</sub> (24,585 N) of installed thrust at static,

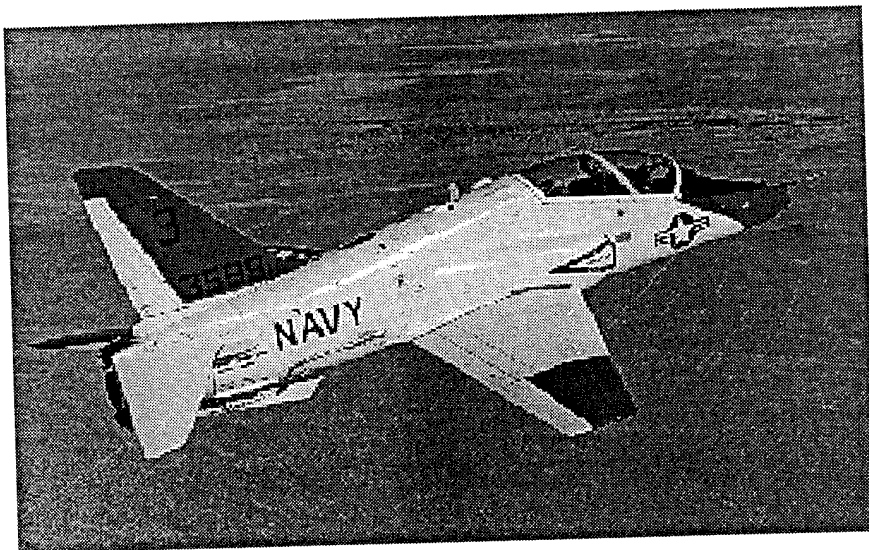
**Figure 1. T-45A Aircraft.**

sea level, standard day conditions. The zero fuel weight of the test airplane was approximately 11,000 lb (4,990 kg) and was capable of carrying 440 gal (1,665 l) of fuel. The 24° swept, laminar flow, transonic wing had full span leading edge slats and double slotted flaps along the trailing edge, a row of 20 vortex generators near the quarter chord and a six inch stall strip on the leading edge sixteen inches from the wing root. The primary flight control system consisted of an all-moveable irreversible hydraulically powered 30° swept and 10° anhedral horizontal stabilator, hydraulically powered ailerons, and a reversible rudder with a no-float mechanism designed to maintain the rudder within 3° to 4° of neutral when no pilot input was commanded. The rudder was designed to break out of the no-float with a maximum rudder pedal input of 13 lb<sub>f</sub> (58 N). A yaw damper controller (YDC) provided slow speed (<217 KIAS) turn coordination, yaw damping, rudder trim, and a speed brake-to-stabilizer interconnect (SBI). The two speed brakes were located on each side of the fuselage just forward of the horizontal stabilator.

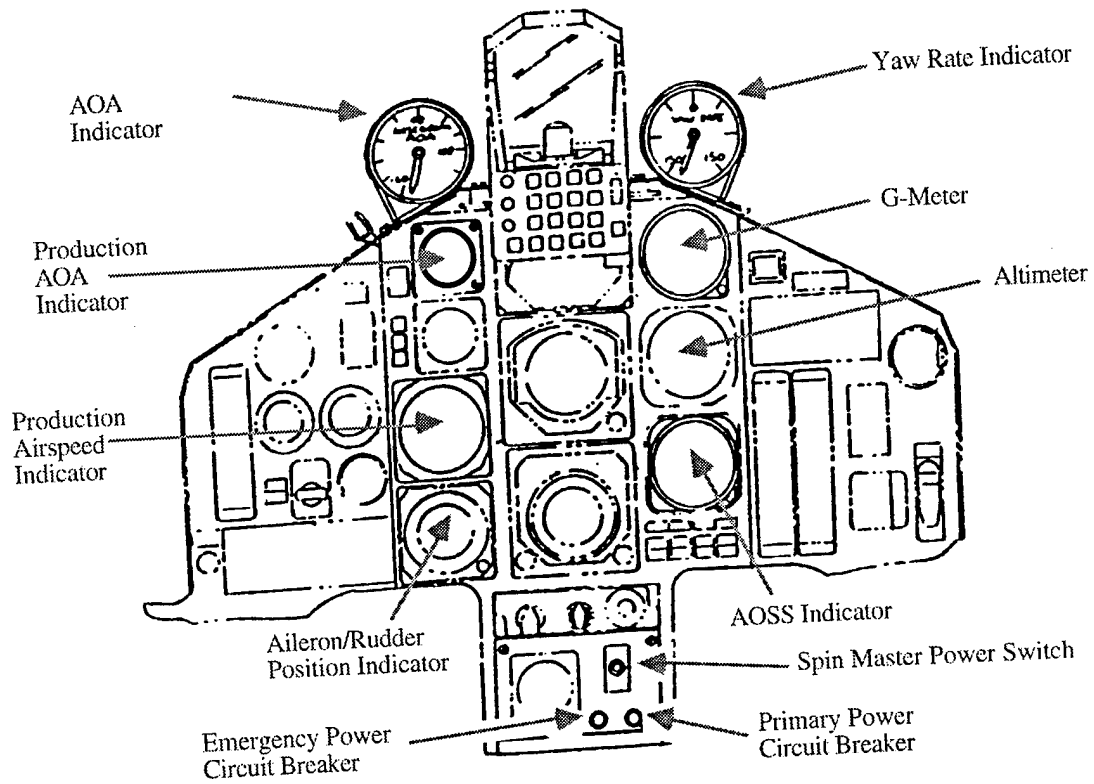
In addition to a supplemental torso restraint installation, the modifications to the forward cockpit made to improve pilot situational awareness are shown in Figure 2.

**Figure 2. Forward Cockpit Main Instrument Panel Configuration.**

Early during testing, the flight test airspeed indicator was replaced by a production airspeed indicator. This was due to the large fluctuations in the flight test airspeed indicator needle during spins rendering the indicator useless.

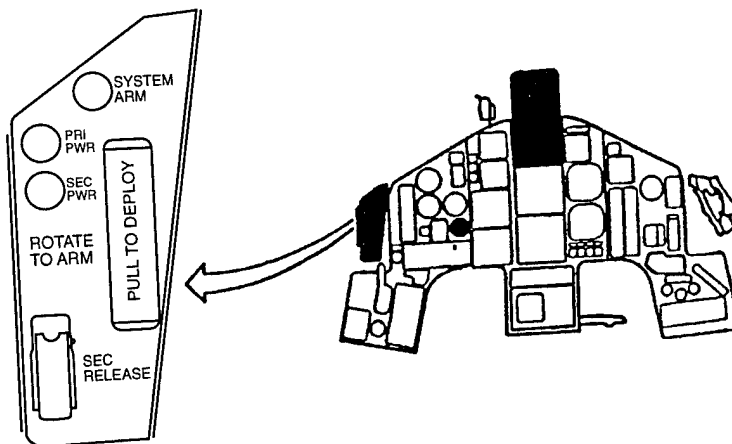
Additionally, the spin chute control panel shown, in Figure 3, replaced the production armament control panel on the left main instrument sub-panel. An over-the-shoulder video camera was mounted on the bulkhead aft of the pilot's left shoulder. A gaseous oxygen tank, mounted in the aft cockpit, replaced the production T-45A On-Board Oxygen Generating System (OBOGS) to provide the pilot with an uninterrupted flow of oxygen in the event of an engine shutdown or failure.

**Figure 3. Spin Chute Control Panel.**

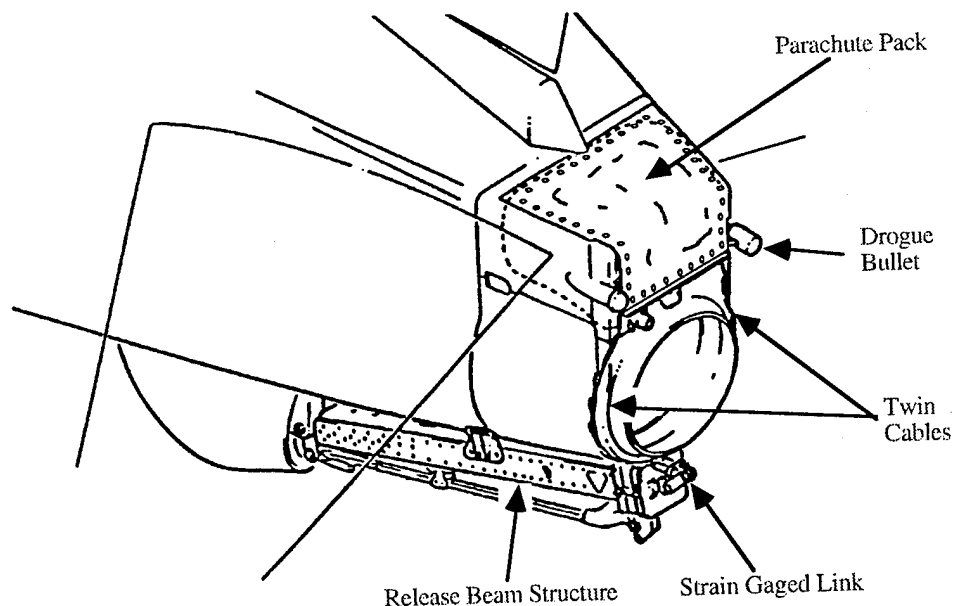
The spin chute system, (see Figure 4) was a modification of the normal brake chute of the BAe HAWK designed for a maximum deployment speed of 158 KEAS. The normal tailhook attach point was used for the spin chute attachment point through the use of a parachute beam structure.

**Figure 4. Spin Chute Installation.**

There were two spin chute release systems: a mechanical system as the primary and the back-up method by an explosive bolt. The spin chute system was fully instrumented and chute status was displayed to the pilot (see Figure 3) and telemetered to the ground data station. Spin chute system affected the aircraft inertia with a slight (6%) increase on  $I_x$  and  $I_y$  and was predicted to negligibly affect the aircraft aerodynamically. As a result of the structural failure of the

spin chute during the April 7, 1993 delayed recovery the steel cables were changed to kevlar straps and were layer-packed vice packed in an interwoven coil.
